Manhole Inspection Summary

Manhole # S69M__002MH

Location Address: **6719 German Hill Rd.**

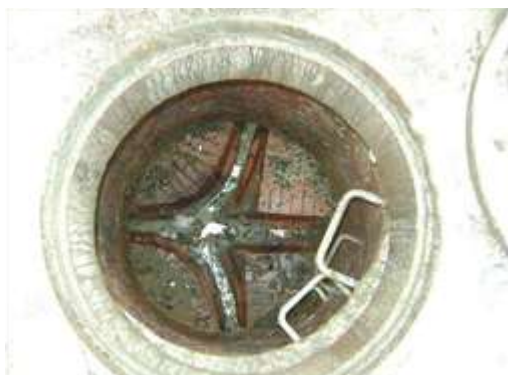
Defect 1

Frame Offset: **1.5** (in.) Condition: ☒ Sound ☐ Cracked ☐ Leaks

1.5 frame offset

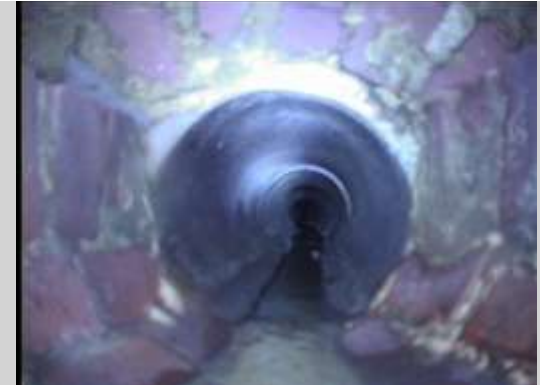
12 O'Clock Outflow

8 in. Circular Gravity Sewer
Pipe Out @ 12 O'Clock

Pipe Height: **8.4** (in.) Rod and Bar (Angled)
Pipe Material: **Clay** ☐ Pipe Lined
Invert Depth: **8.08** (ft.) Flow Characteristics: **None**
Deposits: ☐ None ☐ Mud ☒ **Sludge** ☒ **Debris** ☐ Grease
Silt Depth: **0.25** (in.) Deposits Extent: **Light**
Infiltration: **None** Pipe Seal Cond: **Sound**

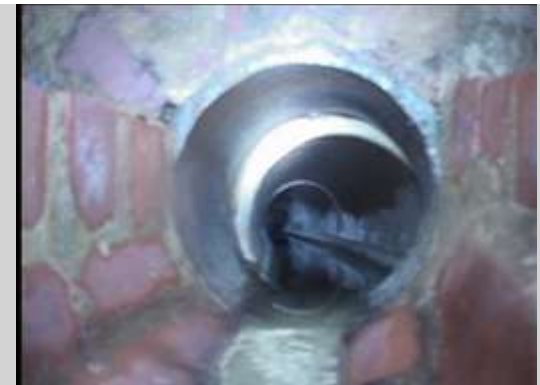
3 O'Clock Inflow

8 in. Circular Gravity Sewer
Pipe In @ 3 O'Clock

Pipe Height: **8.4** (in.) Rod and Bar (Angled)
Pipe Material: **Clay** ☐ Pipe Lined
Invert Depth: **7.88** (ft.) Flow Characteristics: **None**
Deposits: ☐ None ☐ Mud ☒ **Sludge** ☒ **Debris** ☐ Grease
Silt Depth: **0.25** (in.) Deposits Extent: **Light**
Infiltration: **None** Pipe Seal Cond: **Sound**

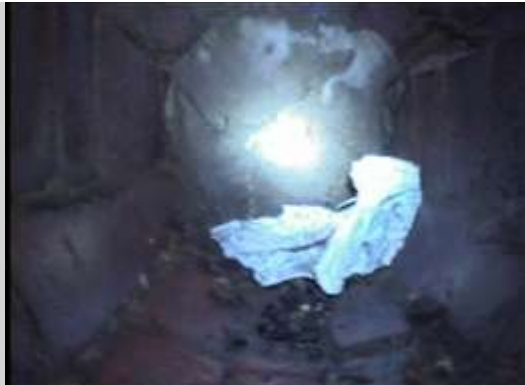
6 O'Clock Inflow

Pipe In @ 6 O'Clock

Deposits: ☐ None ☐ Mud ☒ **Sludge** ☒ **Debris** ☐ Grease

Silt Depth: **0.25** (in.) Deposits Extent: **Light**

Connects To: **Stub connection / abandoned**

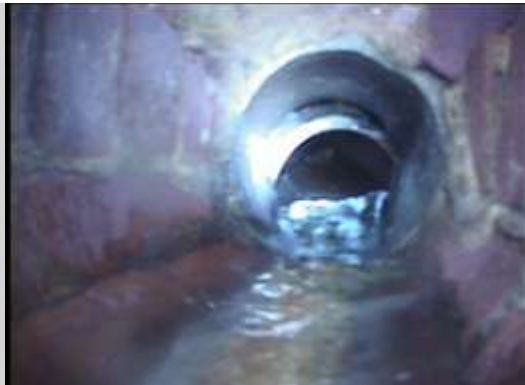
9 O'Clock Inflow

Pipe In @ 9 O'Clock

Deposits: ☐ None ☐ Mud ☒ **Sludge** ☒ **Debris** ☐ Grease

Silt Depth: **0.25** (in.) Deposits Extent: **Light**

Connects To: **House connection / Service line**
